Name Of Dam: FALLING CREEK
Location: BEDFORD COUNTY
Inventory Number: 01910

PHASE I INSPECTION REPORT NATIONAL DAM SAFETY PROGRAM

PREPARED BY
NORFOLK DISTRICT CORPS OF ENGINEERS
803 FRONT STREET
NORFOLK, VIRGINIA 23510

SEPTEMBER 1979

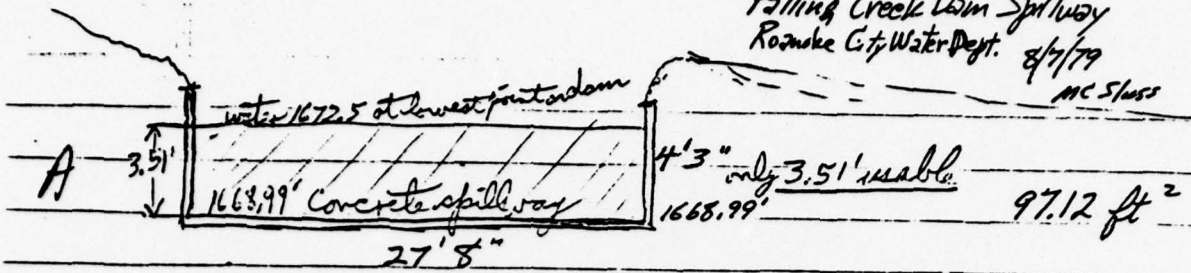
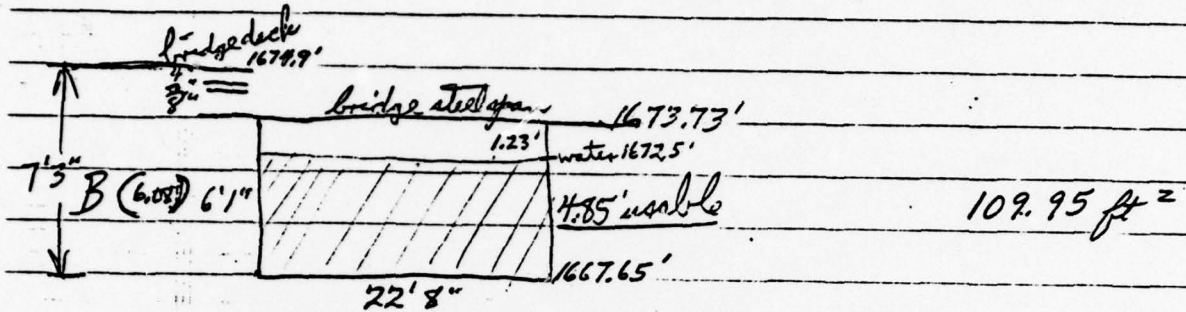
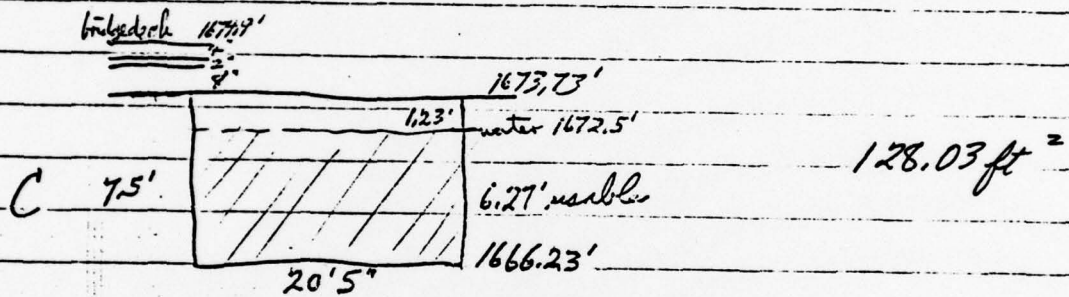
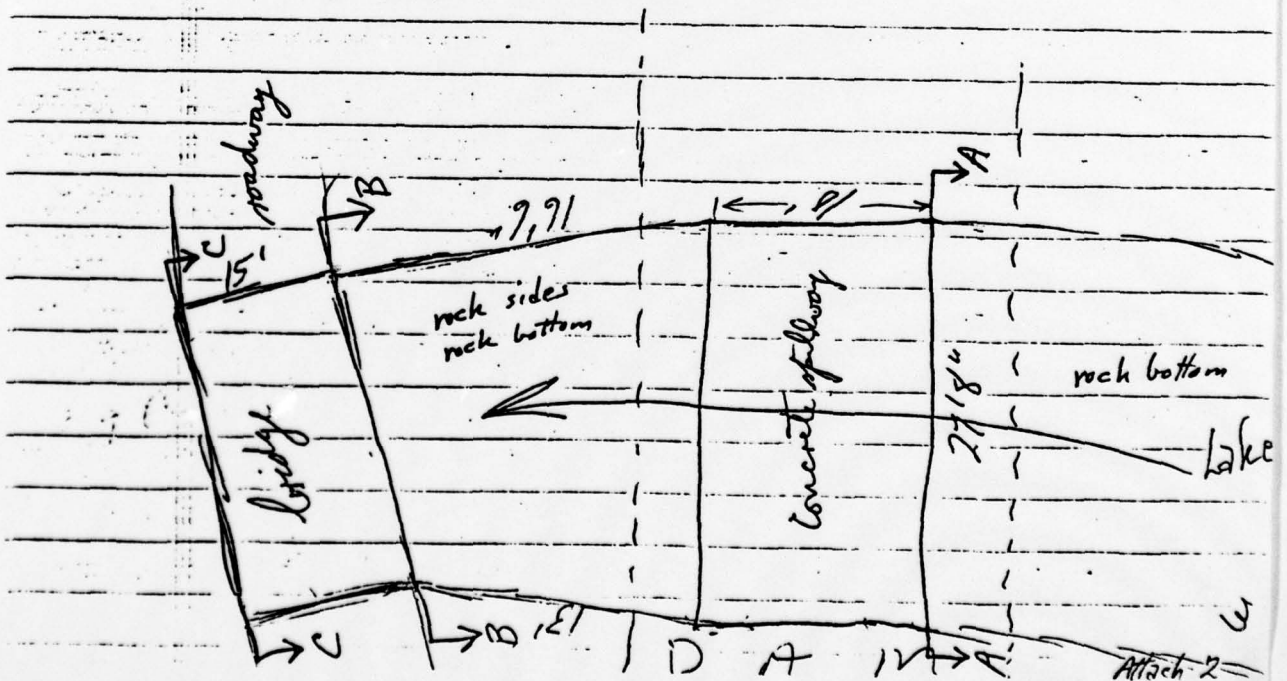
Attach 2

Falling Creek Dam Spillway
 Roanoke City Water Dept. 8/7/79
 MC Shoss

1/ The owner has corrected remedial measures during the restoration of the original spillway in July 1979.
